OCCASIONAL PAPER 133

PREVENTING AND CONTROLLING WATER-CONDUCTING ROT IN BUILDINGS

A. F. Verrall

SOUTHERN FOREST EXPERIMENT STATION

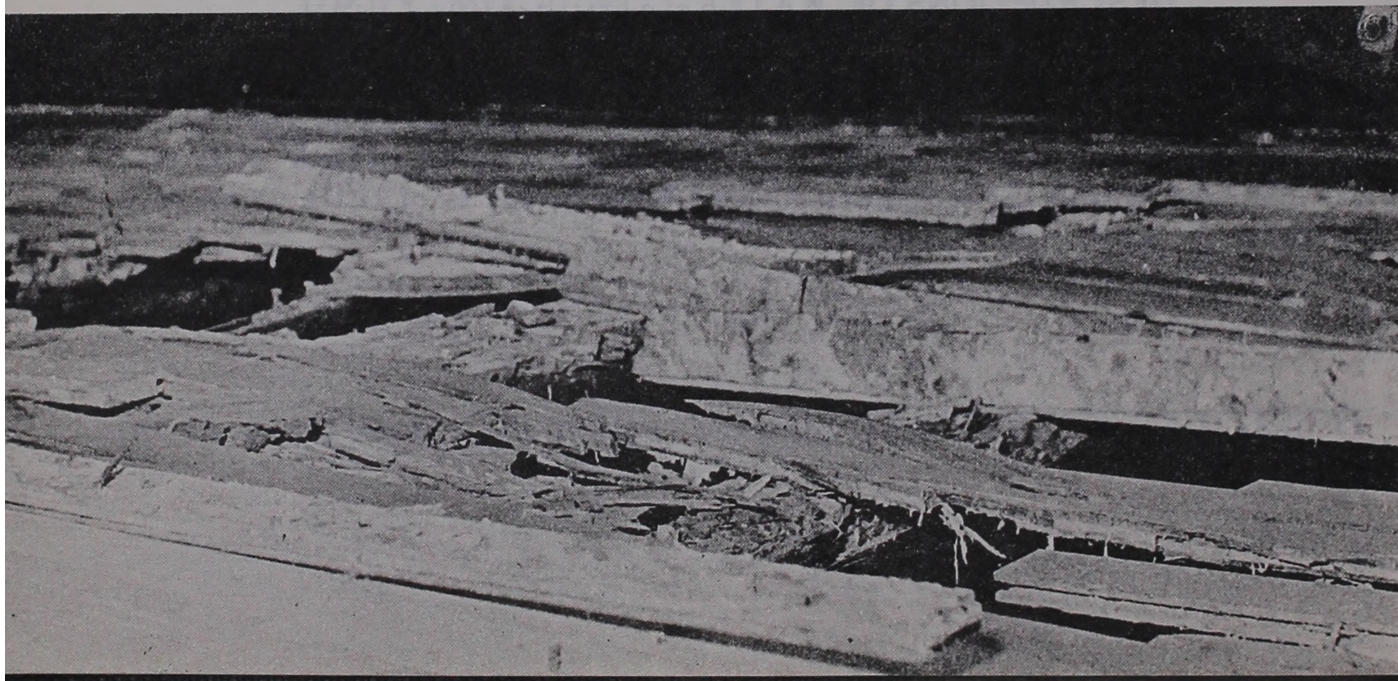
When a water conductor occurs in a building, the extent and rapidity of attack may be spectacular (6, 9). Poria causes a brown cubical rot, usually starting in the substructure--the sills, first-floor joists, nailing strips, wall plates, etc. (fig. 1). Later it may work up into the walls and even attack the second floor. By this time all structural and trim items in the area of the original attack may be damaged. Oftentimes owners are unaware of the attack until a floor fails, doors settle, sunken areas appear in baseboards, or a yellowish-white fungus felt appears under a rug or in a cupboard. When the wall or floor is opened for repairs, extensive yellowish-white mycelial mats (fig. 2) are usually found between sheathing and building paper or between two wood surfaces as finish and subfloors.

Figure 1. --Flooring badly decayed by Poria.

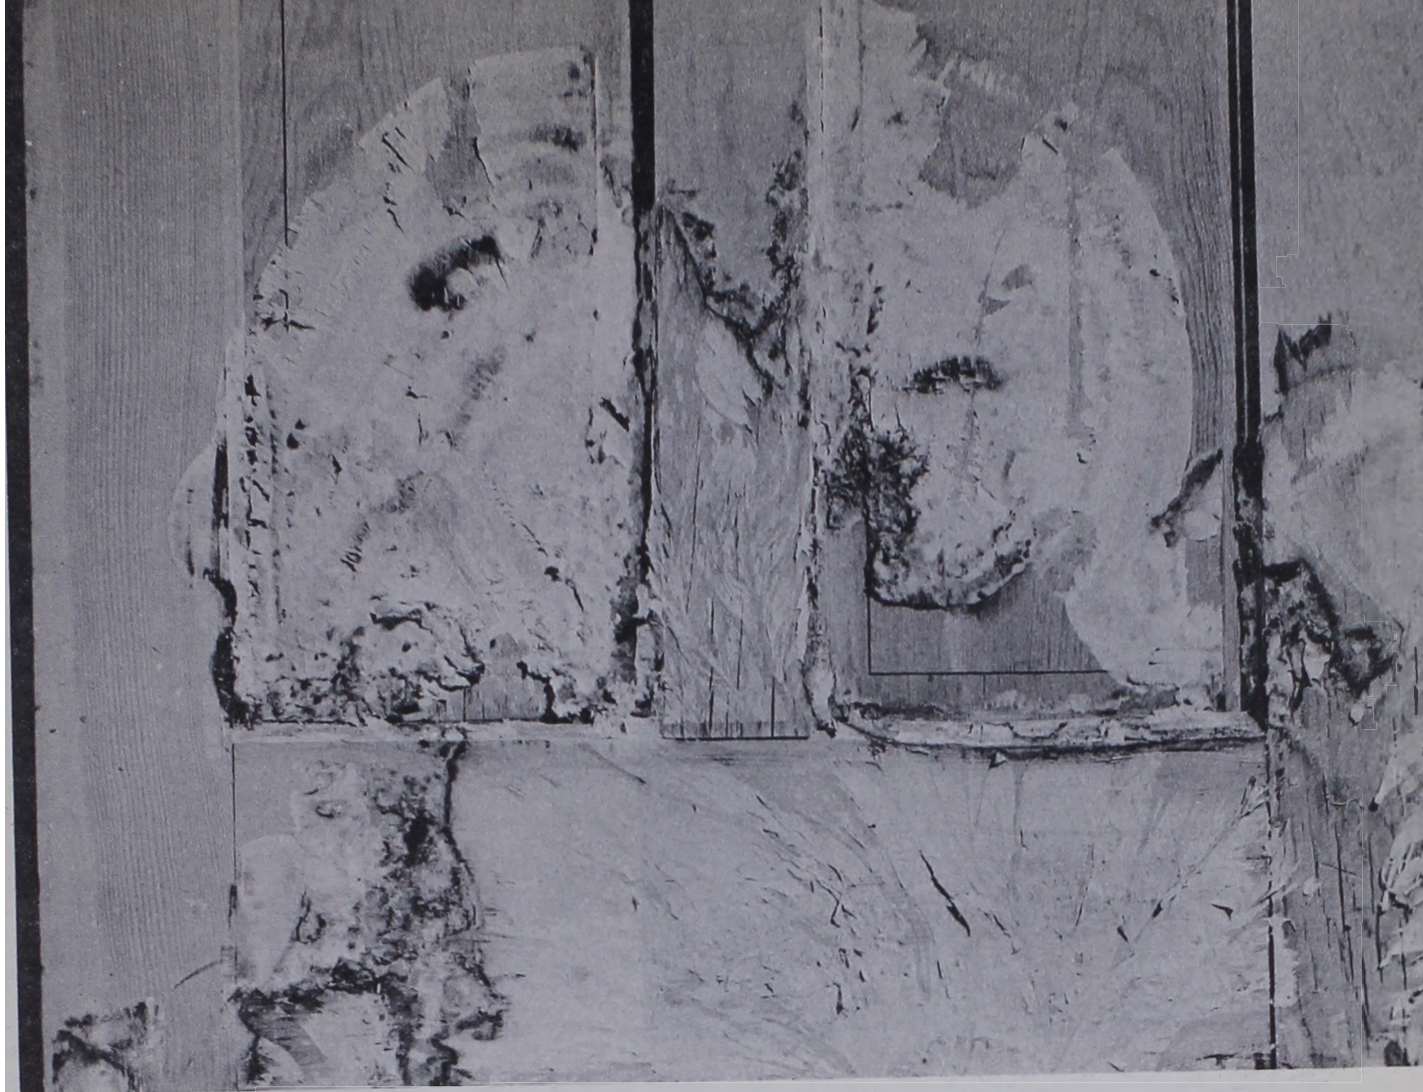
Figure 2. --Mycelial growth of Poria on the back of a wood panel.

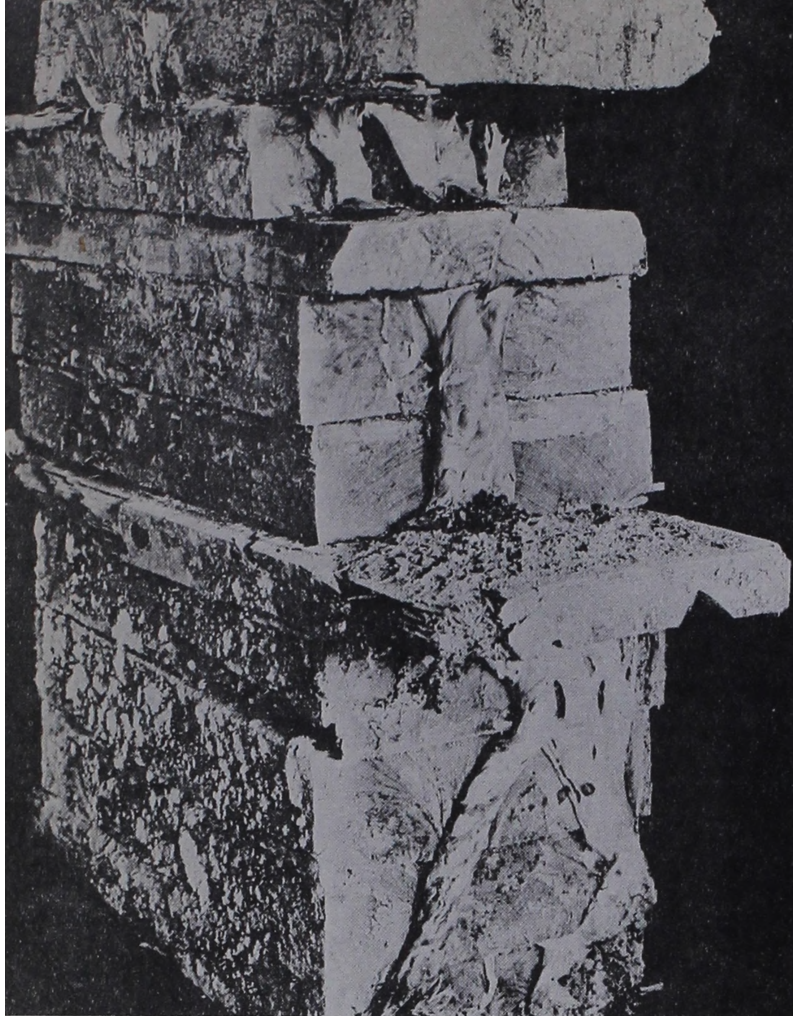
When extensive damage occurs, rhizomorphs (water-conducting strands) from a small fraction of an inch to 2 inches in diameter can usually be found (fig. 3). They extend from the soil or other constant water source up into the wood structure. It is these rhizomorphs and well-developed mycelial fans that permit Poria to conduct water to wood normally too dry to decay. When decay is more restricted, definite rhizomorphs may be lacking but the mycelial mats show a tendency to form strands. Laboratory studies^{2/} have shown that Poria can conduct water at least 5 feet up wood columns. Observations in buildings indicate that this fungus can conduct water at least 20 feet horizontally and 12 feet vertically.

Figure 3. --Water-conducting rhizomorphs growing on the ends of piled lumber.

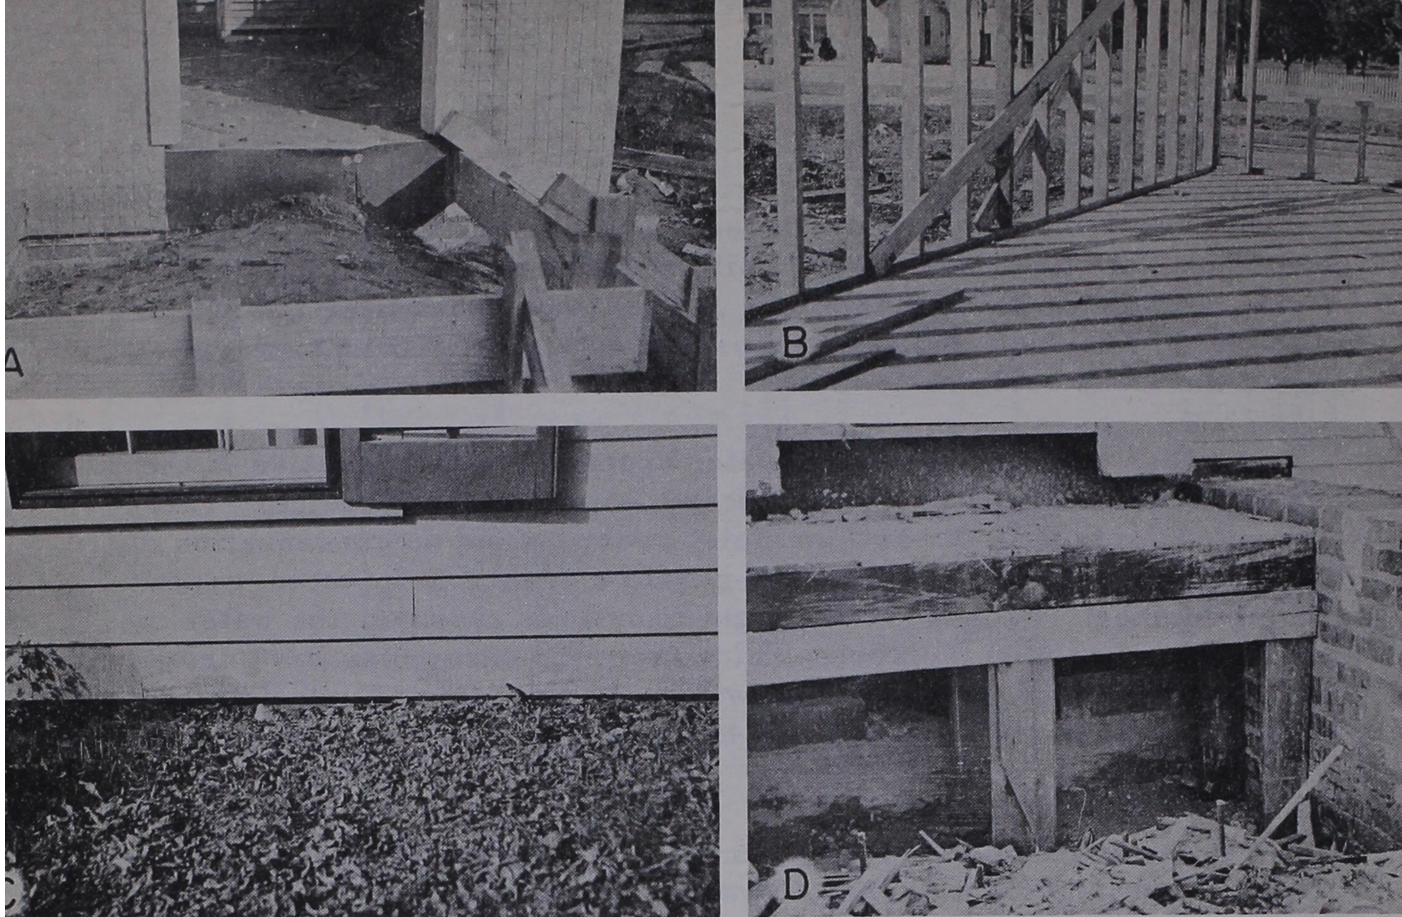
(1) Dirt-filled porches with an untreated sill or header in contact with the dirt fill or separated from it only by asphalt-impregnated sheathing paper (fig. 4A). The dirt-filled porch has led to so much decay and termite trouble that extreme caution should be exercised in including this type of construction in a building. It is much safer to use a self-supporting slab with the subslab area open to the crawl

Figure 4. --Some common practices leading to attack by water-conducting fungi. A, The dirt fill for this porch is separated from the untreated sill only by sheathing paper. B, Non-waterproofed groundline concrete slab. C, Untreated wood in contact with soil. D, If these forms are left after the stoop slab is poured, they will make a wooden contact between the soil and the sill of the house.

(3) Untreated wood on moist groundline concrete slabs (fig. 4B). Even when water-conducting rot does not occur, this condition usually leads to floor buckling and damp living quarters. Poria can become established in wall plates and nailing strips and can secure enough water from the soil through the slab to cause extensive decay. When severe water-conducting rot is associated with wooden floors and walls on a damp concrete slab, there is no sure way of control except to remove the floor, replace the wall plates with pressure-treated wood, and add a moisture-proof membrane to the slab, being sure that it extends under the wall plates. New nailing strips and subflooring should be pressure-treated. This is the most expensive and discouraging type of Poria attack to correct. Many of the houses attacked in this way have been torn down completely and replaced with other types of construction. When the attack is not too severe there is a possibility that control could be secured by removing wooden floors and replacing badly damaged wood in the walls, using treated plates. Then the unattacked plates could be given some protection by flowing 5 percent pentachlorophenol over and under them. A non-wood floor would then be used. There is no record of such a treatment but it should stand a good chance of success.

(4) Sheathing, siding, and trim in contact with the soil (fig. 4C). In most cases this was due to careless grading or the building up of flower beds. Rich, mulched flower beds seem to be an ideal place for the rooting of a well-developed rhizomorph system. As long as siding and trim is kept to the usually recommended minimum of 6 inches from the soil, there should be no danger of its being an entrance point for Poria. A number of houses were found, including one with heavy Poria attack, in which the sheathing was brought down to the soil to act as a support for metal lath and stucco. The wood between the stucco and the foundation piers could be removed only by removing the stucco.

(6) Wooden forms left on foundations, steps, and porch slabs (fig. 4D). Although only two cases were traceable to this condition, the common practice of leaving forms in hidden places is risky. The cost of

space or cellar. When the slab is a step or two lower than the house floor the fill may be entirely below the wood, in which case there is little danger. Attack may also be prevented by the insertion of a continuous non-corrosive metal shield. Such a shield should extend down from under the siding, over the outside and underside of the sill to the crawl space, and there should bend downward at 45° for 2 inches. There is also a possibility that attack of both decay and termites can be prevented by treating the fill with fungicides and insecticides before the slab is poured. Tests on the effectiveness of soil fungicides have been started. The easiest way, however, is to avoid the dirt fill.

When attack involves a dirt fill the usual correction consists of removing a section of the foundation and excavating the fill away from the sill. The excavation should be sufficient to permit crawling along the sill for inspection. The concrete slab and foundation exposed by the excavation should be scraped clean and painted or sprayed with

creosote or with 5 percent pentachlorophenol in a petroleum oil. In one case a 12-inch strip of the porch slab was removed next to the sill and enough fill removed to insert a new pressure-treated sill. The excavation was filled with creosote-treated cinders and the slab was repaired. This, however, did not leave as finished-appearing a job as the usual excavation from the underside.

Because of the difficulty and expense of correcting an attack in wooden houses laid on groundline slabs, care should be taken to insure that the construction is safe from the start. Concrete slabs for houses should be elevated so the top surface is 12 inches above grade, the slab poured on a layer of gravel, and a water-proof membrane used either below or on top of the slab. No grade stakes should be left in the slab. When these recommendations are followed, there usually is no trouble with decay. Nevertheless it is best also to use treated wall plates, nailing strips, and subflooring.

removal is so small that it is almost inconceivable that people leave them. If decay does not occur, termite attack may.
